**Lagoons Catchment Management Plan**  
**Water Quality Monitoring Program**  
**Mackay Regional Botanic Gardens**

12 May 2014  
Revision: 0  
Reference: 240114

# Lagoons Catchment Management Plan

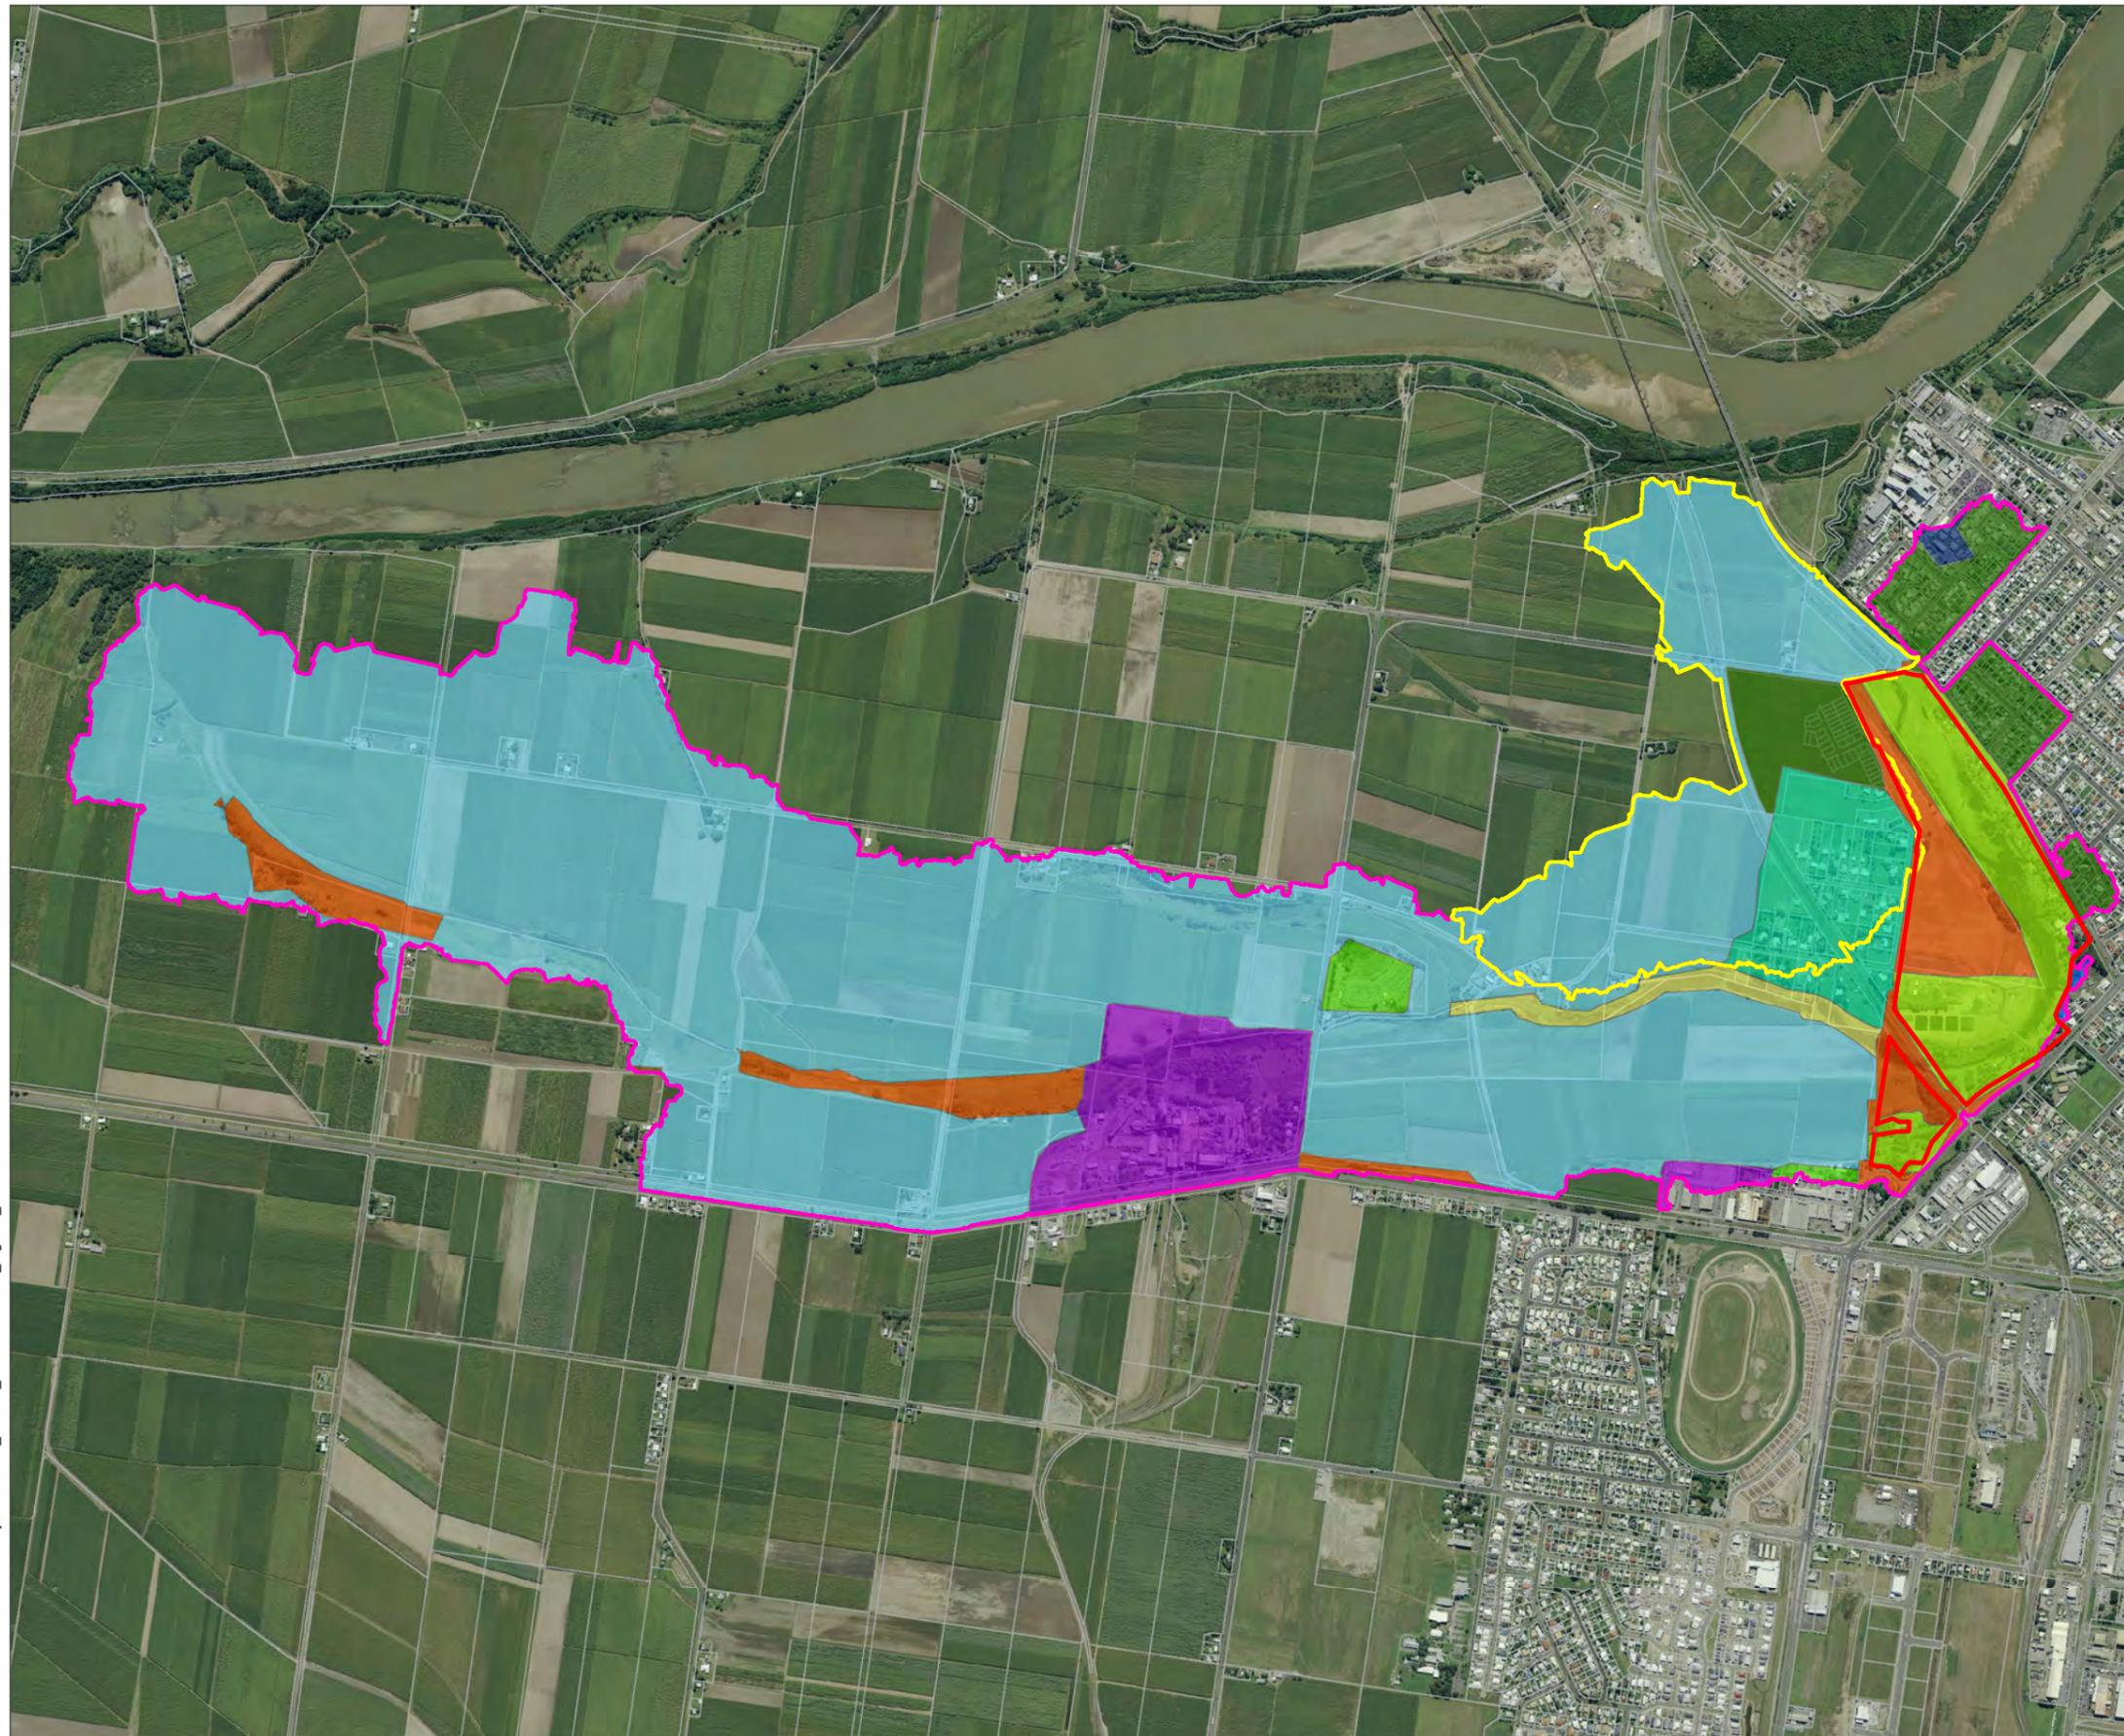
**Figure 3: Landuse distribution within the Lagoons Catchment**

The distribution of these land uses throughout the Lagoons Catchment is illustrated in Figure 3 and the relative proportion of each by area is provided in Figure 4.

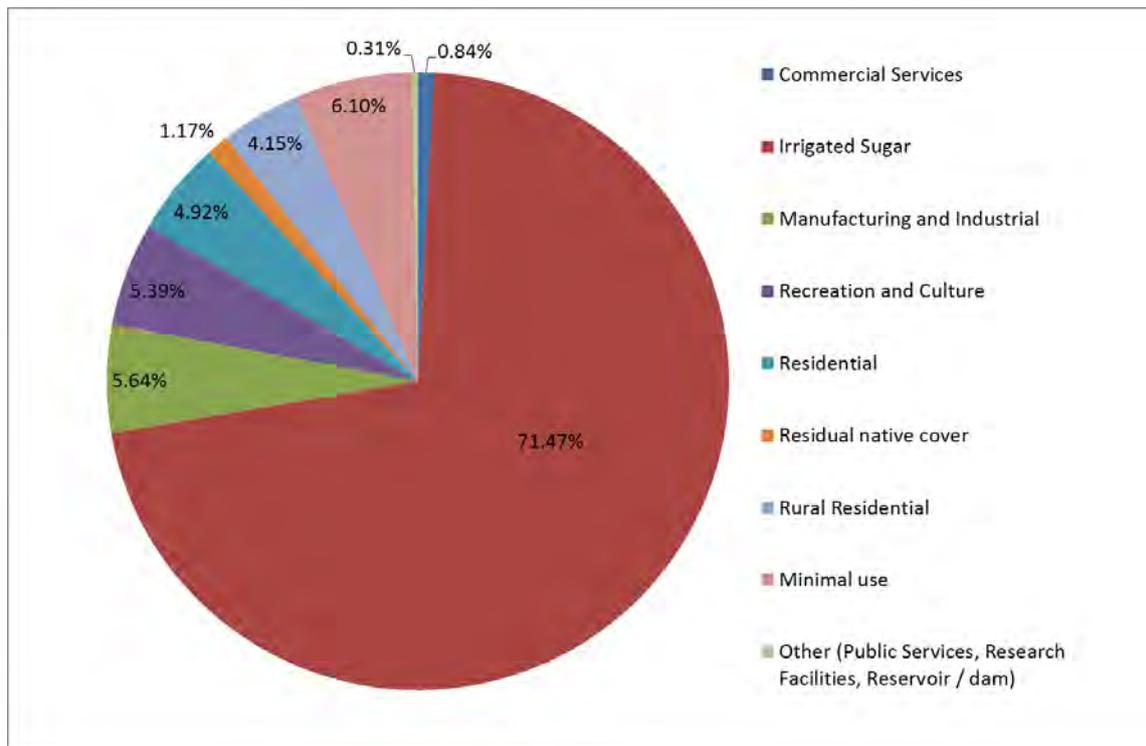
Figure 4: Diagrammatic illustration of landuse proportion within the Lagoons Catchment (by zoning area)

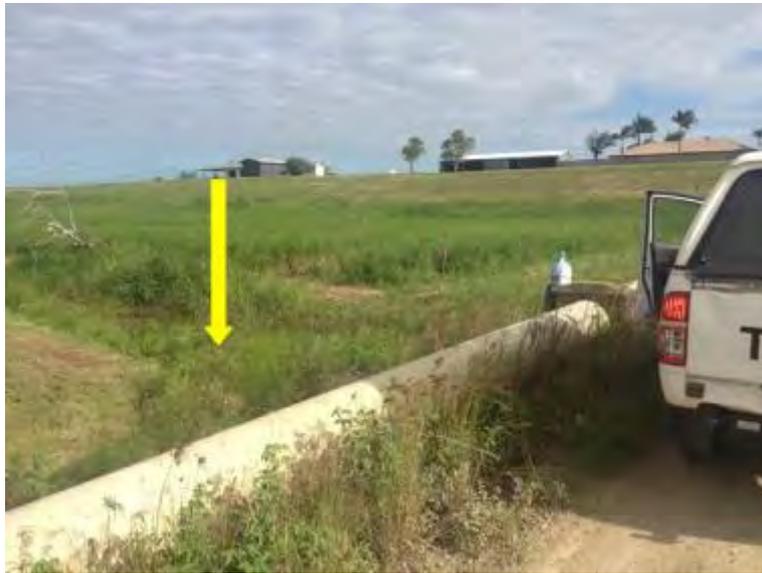
Sample location LWQ-1 is located in the upper reaches of the Lagoons Catchment at the Hills Road culvert, accessed from Hills Road (Longitude: 149.113114, Latitude: -21.158228). The proposed sample point is the downstream side of the culvert where access is relatively easy from the northern bank as illustrated in Figure 6.

Figure 6: Sample location LWQ-1 (yellow arrow = suggested sampling point)

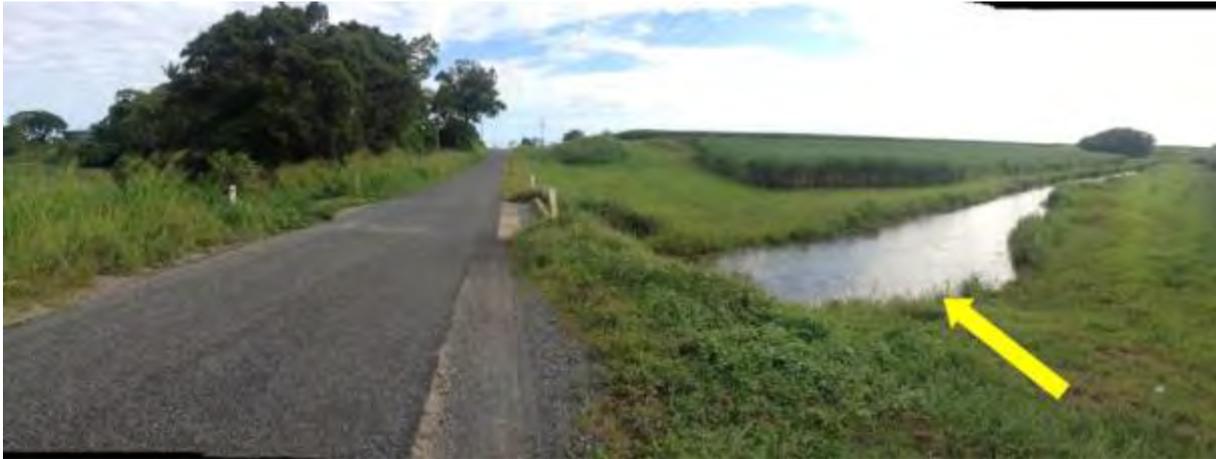
Sample location LWQ-2 is located immediately up stream of the Racecourse Sugar Mill accessed from Ta Kowai Foulden Road (Longitude: 149.128229, Latitude: -21.162547). The proposed sample point is the upstream side of the culvert where access is relatively easy from the northern bank (Figure 7).

Figure 7: Sample location LWQ-2 (yellow arrow = suggested sampling point)

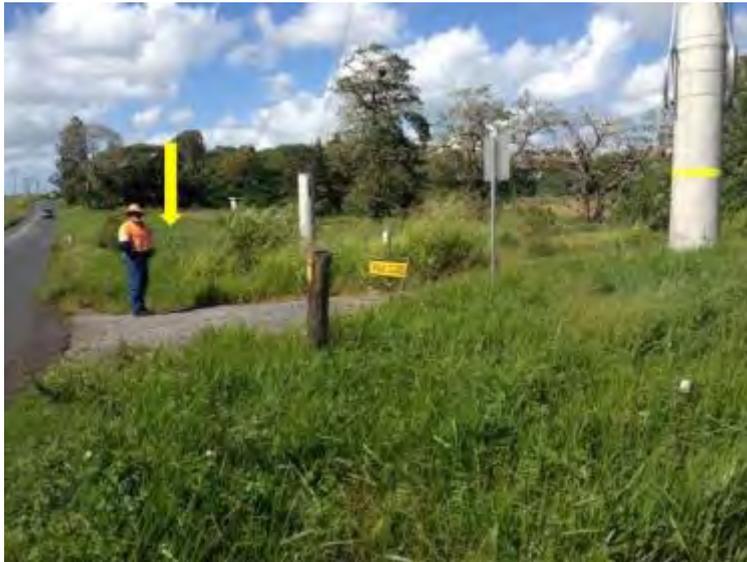
Sample location LWQ-3 is located immediately downstream of the Racecourse Sugar Mill accessed from Horse and Jockey Road (Longitude: 149.138434, Latitude: -21.16154). The proposed sample point is the upstream side of the culvert (Figure 8).

Figure 8: Sample location LWQ-3 showing access road and sample location (yellow arrow = suggested sampling point)

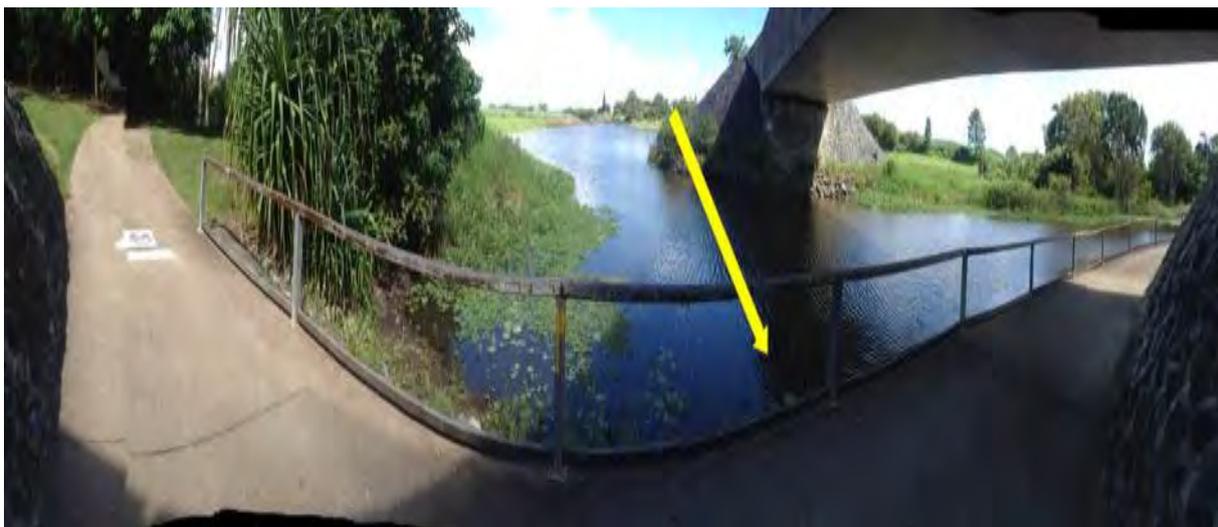
Sample location LWQ-4 is located in the upper reaches of Kaliguil Lagoon accessed on foot from Crowleys Road via the MRBG walkway (Longitude: 149.155532, Latitude: -21.162022). The proposed sample point is from underneath the railway bridge, off the walkway Figure 9.

Figure 9: Sample location LWQ-4 (yellow arrow = suggested sampling point)

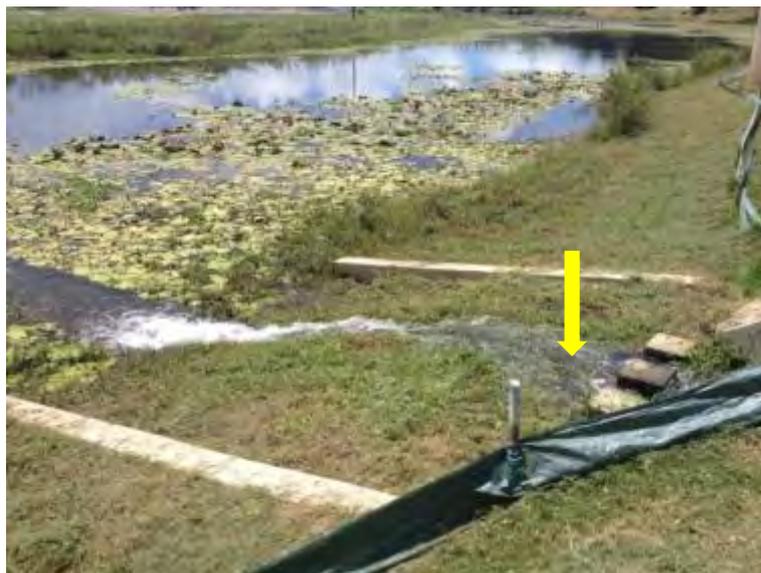
Sample location LWQ-5 is the filter water discharge point for the Mackay Water Treatment Plant back flush water, located just to the north of Crowleys Road fjord / culvert on the western bank of the Eulamere Lagoon (Longitude: 149.158547, Latitude: -21.161089). The proposed sample point is as close as possible to the outlet Figure 10.

Figure 10: Sample location LWQ-5 (yellow arrow = suggested sampling point)

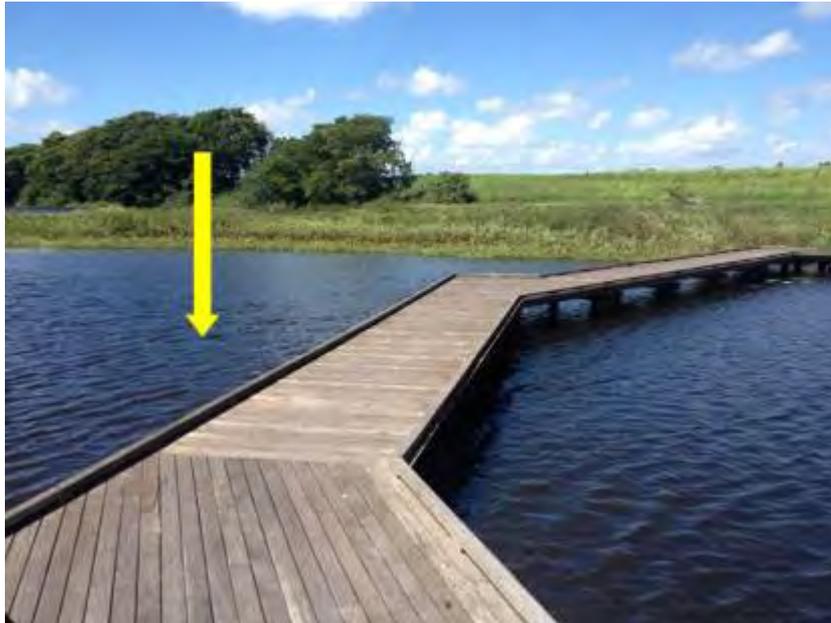
Sample location LWQ-6 is located towards the tail end of the Lagoons system and is accessed from the MRBG walkway and over-water boardwalk (Longitude: 149.157435, Latitude: -21.15577). The proposed sample point is from the approximate centre of the traverse of the boardwalk on the upstream side as illustrated in Figure 11.

Figure 11: Sample location LWQ-6 (yellow arrow = suggested sampling point)

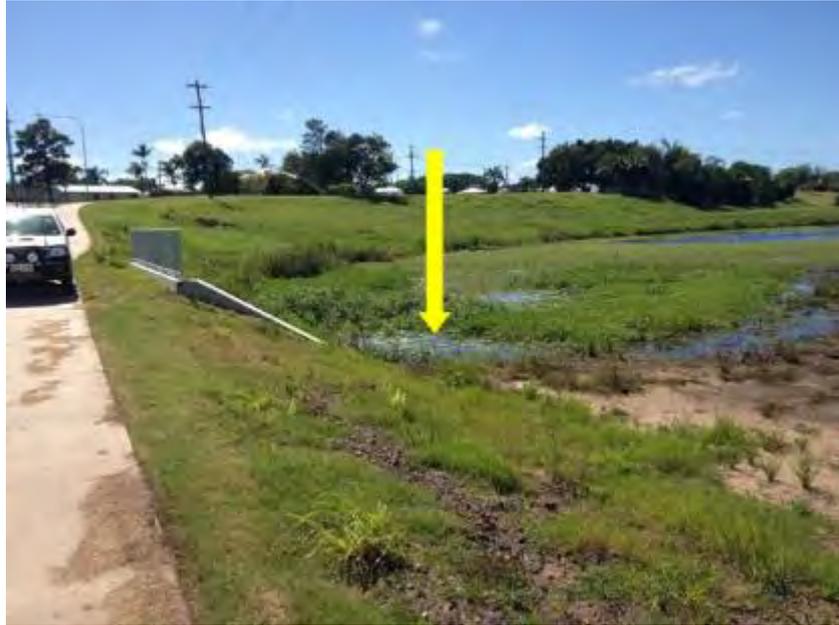
Sample location LWQ-7 is located immediately upstream of the Landsdowne Road culvert, accessed from Landsdowne Road (Longitude: 149.154326, Latitude: -21.151667). The proposed sample point is the upstream side of the culvert where access is moderately easy from the western side as illustrated in Figure 12 (sampling on the downstream side should be avoided as water cascades through the culvert and this is likely to bias water quality results, particularly regarding dissolved oxygen content).

Figure 12: Sample location LWQ-7 (yellow arrow = suggested sampling point)

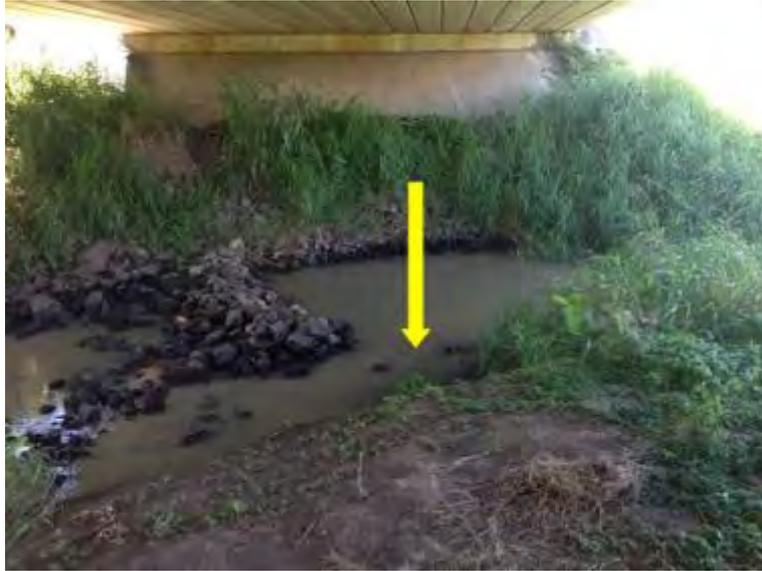
Sample location LWQ-8 is located under the Glenella Road bridge as it passes over the Lagoons creek, accessed from Glenella Road (Longitude: 149.152346, Latitude: -21.146145). The proposed sample point is directly under the bridge as shown in Figure 13. Sampling any further downstream is not advisable as the aquatic environment becomes increasingly estuarine, particularly during high tides.

Figure 13: Sample location LWQ-8 (yellow arrow = suggested sampling point)

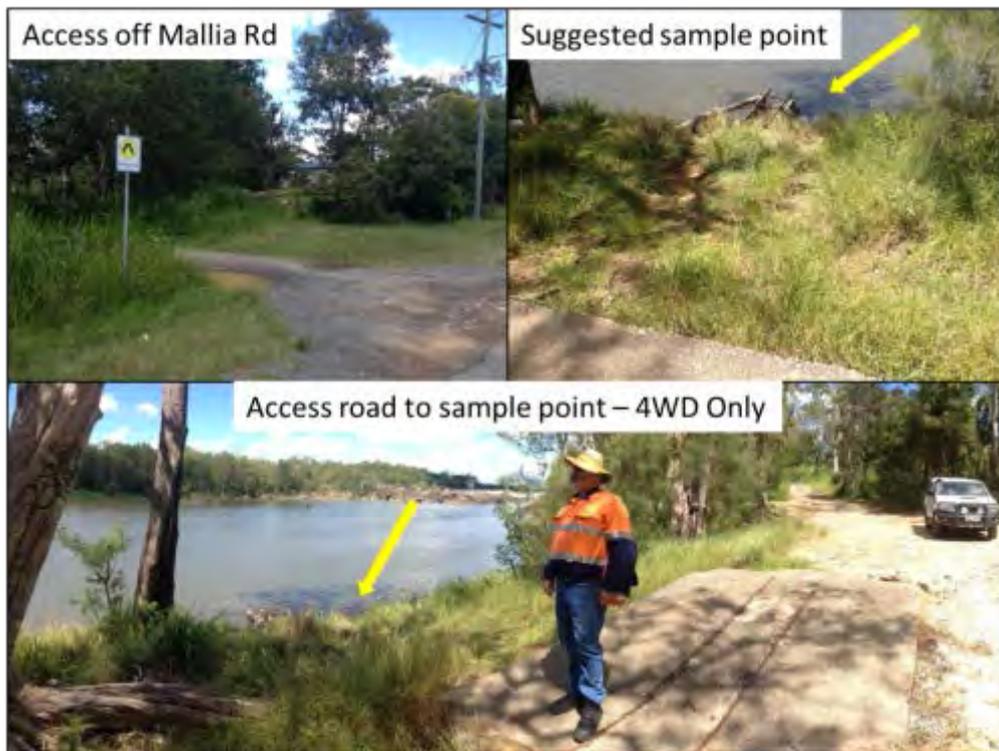
Sample location LWQ-9 is located immediately downstream of the Dumbleton Weir on the Pioneer River, accessed from Mallia Road, Dumbleton (Longitude: 149.07973, Latitude: -21.149145). The proposed sample point is the downstream side of the weir where access is relatively easy from the northern bank as illustrated in Figure 14.

Figure 14: Sample location LWQ-9 (yellow arrows = suggested sampling point)

- If possible, LWQ-9 should be located immediately upstream of the Dumbleton Weir to avoid the issues described above, however this land is controlled by Pioneer Valley Water Board (PVWB). It is therefore highly recommended that permission will be sort from the PVWB to move LWQ-9 from its current proposed location to upstream of the weir.

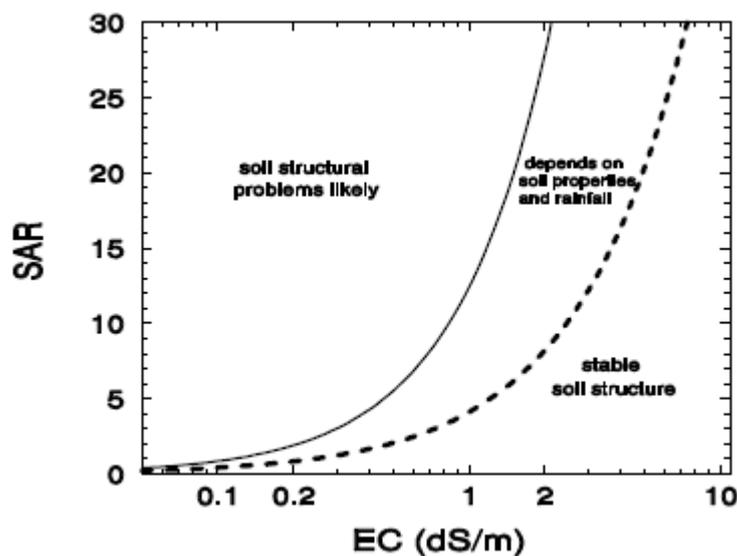
In addition to Table 5, the risk of soil structure degradation in cane fields should also be determined. A preliminary assessment can be determined by calculating the sodium absorption ratio (SAR) and plotting it against the waterways measured EC value on the graph provided in Figure 16. The SAR value can be calculated by taking the concentrations of sodium ( $\text{Na}^+$ ); Calcium ( $\text{Ca}^{2+}$ ) and magnesium ( $\text{Mg}^{2+}$ ) as  $\text{mmole}_c/\text{L}$  (where subscript C is change) and applying the following formula (ANZECC and ARMCANZ, 2000d):

Figure 16: Relationship between SAR and EC of irrigation water for predicting soil structural stability (source: Figure 4.2.2, ANZECC 2000)

Should the resultant SAR ratio consistently fall outside of the “stable soil structure” zone provided in Figure 16, then further investigation should be undertaken, involving the assessment local farming soils to establish if water extracted from the Lagoons Catchment represents a threat to the long term viability of irrigated soils.

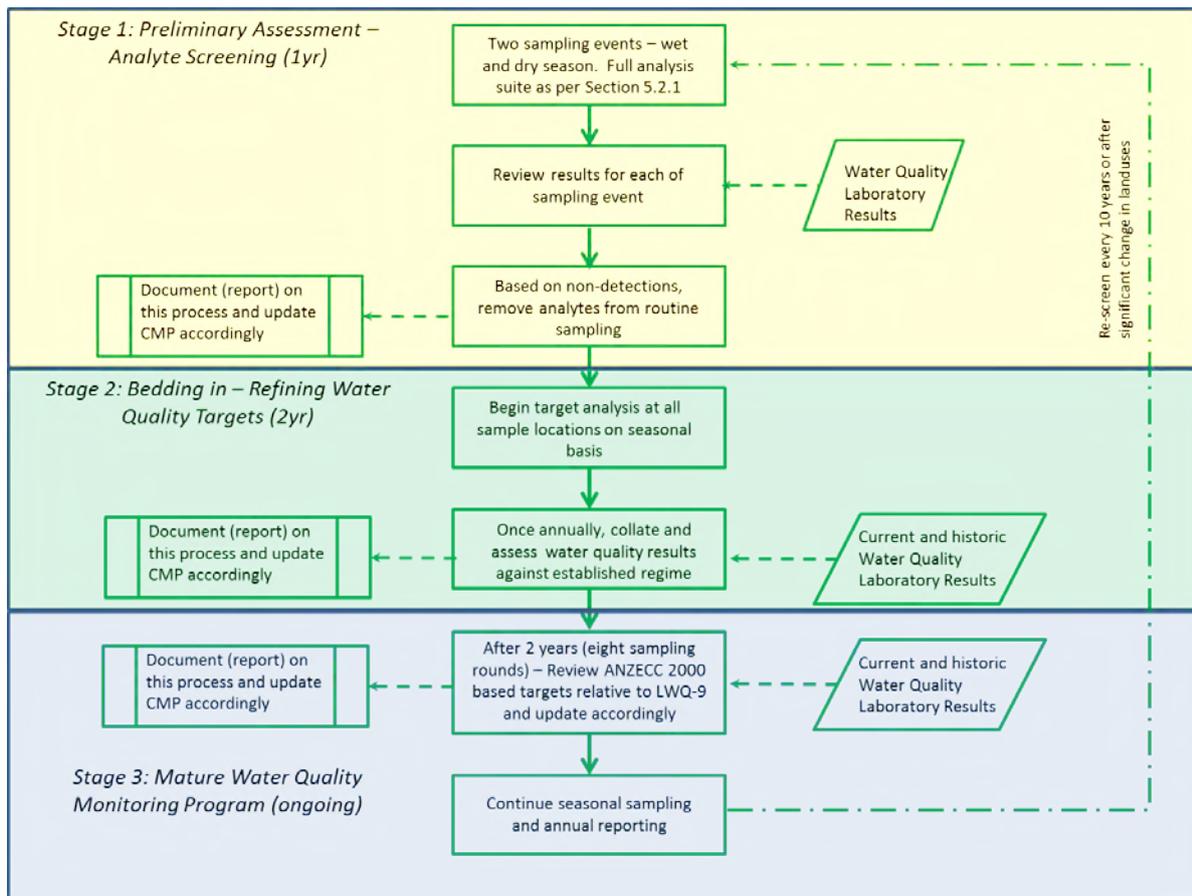
guidelines, it is recommended that the WQMP be rolled out in a staged manner. This process is described below and illustrated in Figure 17.

Figure 17: Process for rolling out the Lagoons Catchment WQMP.

This stage represents the effective end point for establishing the Lagoons WQMP. Sampling can now continue at all sample locations, four times per year. However, as illustrated in Figure 17, Stage 1 and Stage 2 should be revisited every 10 years, or when a significant change in landuse occurs, to ensure the WQMP remains consistent with current conditions (see also Section 5.3.4).

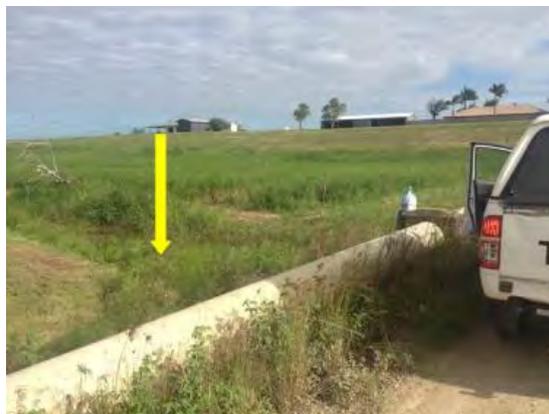
**Figure A1:** Sample Location LWQ-1

Safety and access considerations for LWQ-1 are summarised in Table A1 below. It should be noted that the information contained in Table A1 is based on site conditions on the day the inspection was carried out (26 February 2014, 16:15) which may change over time. Hence the information in Table A1 should be used as a guide only and sampling sites should always be assessed for safe access within one week prior to a sampling event.

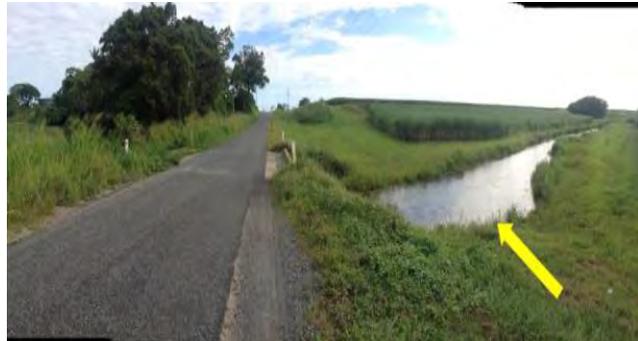
Figure A2: Sample Location LWQ-2

Safety and access considerations for LWQ-1 are summarised in Table A2 below. It should be noted that the information contained in Table A2 is based on site conditions on the day the inspection was carried out (27 February 2014, 16:22) which may change over time. Hence the information in Table A2 should be used as a guide only.

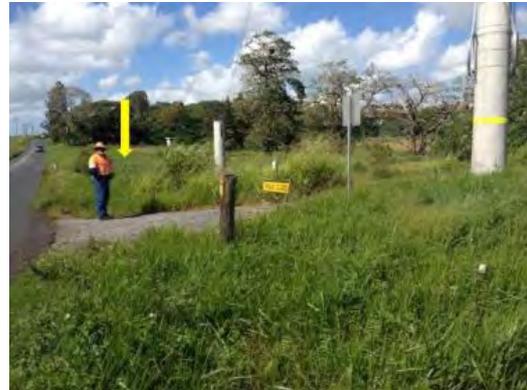
**Figure A3:** Sample location LWQ-3 showing access road and sample location (yellow arrow = suggested sampling point)

Traffic	Moderate to high	Traffic along Horse and Jockey Road consists of fast moving private and commercial vehicles. Further, while a potential parking location is evident (gravel road (Figure A3)), mowing and weed control is required to establish a safe parking area.
Fall	High	Due to dense vegetation present at this location, the ground surface is highly obscured and falls are likely.
Heights	Moderate	Height does not appear to be an issue for this location, however the presence of dense vegetation may be obscuring the true hazards associated with this location.
Mobile equipment interaction	Moderate	Existing gravel road suggests mobile equipment may pass close to this sampling location.
Restricted area	Not applicable	While strictly freehold land, sampling location is outside canfield boundaries and close to road and culvert.
Restricted access (e.g. dense vegetation, long walk, private property)	High	As for uneven surface / steep terrain risk

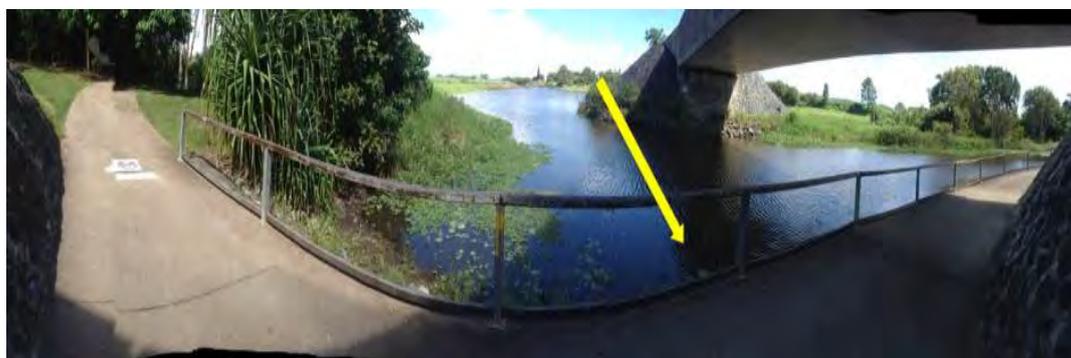
**Figure A4:** Sample location LWQ-4 (yellow arrow = suggested sampling point)

Risk	Risk	Comments
Open water	Low to moderate	Samples are to be collected from behind the hand rail shown in Figure A4. This handrail should always be inspected visually immediately prior to sampling to ensure it is securely bolted in place as there is a fall hazard over rocks to water and the depth of water at this location is not known, and may be overhead.
Fauna (insect, spider, snake, dogs; etc.)	Low to moderate	Snakes may be an issue during warmer months especially.
Flora (sting, poisonous, other)	Low	No stinger species or potentially poisonous species observed.
Uneven surfaces / steep terrain (consider access with sampling equipment in tow).	Low to moderate	Access is on foot via Crowleys Road, entirely along relatively flat walkways.
Traffic	Moderate	While car and truck vehicle traffic is minimal, MRBG service vehicles and bicycles should be expected.
Fall	Low to moderate	The only possible fall risk is falling through the handrail as shown in Figure A4.

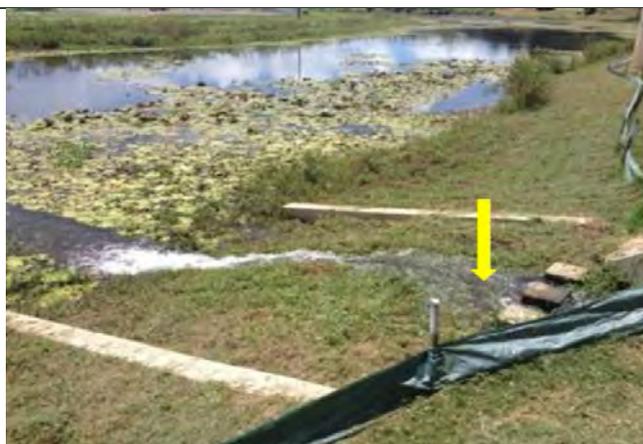
Safety and access considerations for LWQ-5 are summarised in Table A5 below. It should be noted that the information contained in Table A5 is based on site conditions on the day the inspection was carried out (27 February 2014, 09:35) which may change over time. Hence the information in Table A5 should be used as a guide only.

**Figure A5:** Sample location LWQ-5 (yellow arrow = suggested sampling point)

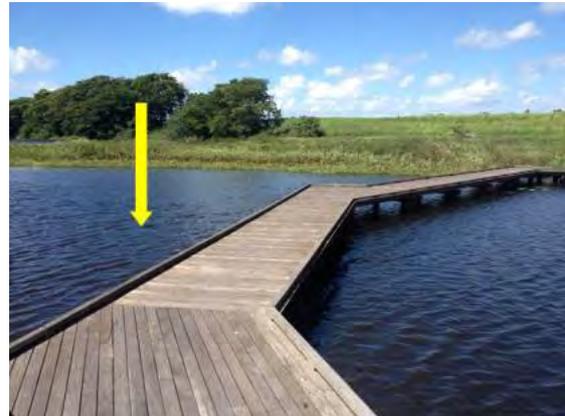
Safety and access considerations are for LWQ-6 are summarised in Table A6 below. It should be noted that the information contained in Table A6 is based on site conditions on the day the inspection was carried out (27 February 2014, 10:00 am) which may change over time. Hence the information in Table A6 should be used as a guide only.

**Figure A6:** Sample location LWQ-6 (yellow arrow = suggested sampling point)

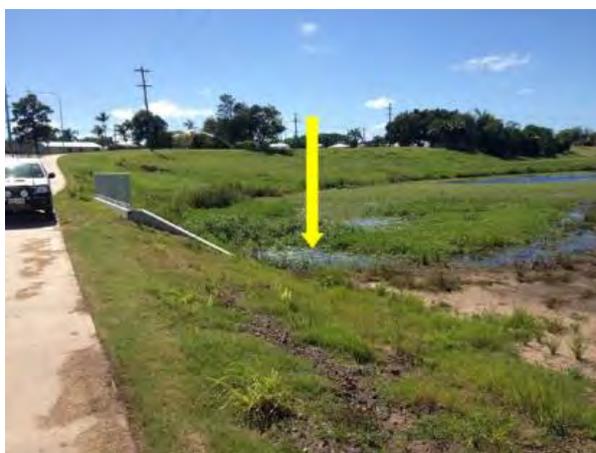
Safety and access considerations are for LWQ-7 are summarised in Table A7 below. It should be noted that the information contained in Table A7 is based on site conditions on the day the inspection was carried out (27 February 2014, 10:10 am) which may change over time. Hence the information in Table A7 should be used as a guide only.

**Figure A7:** Sample location LWQ-7 (yellow arrow = suggested sampling point)

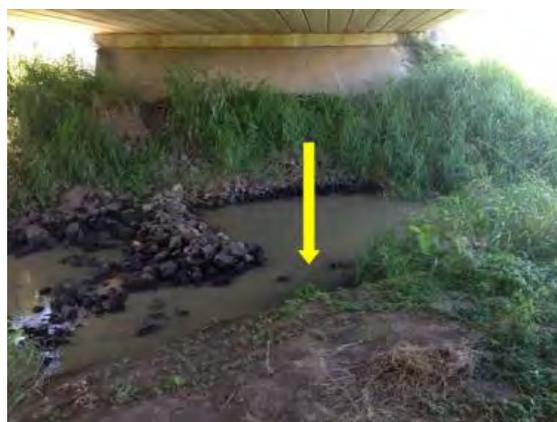
Safety and access considerations are for LWQ-8 are summarised in Table A8 below. It should be noted that the information contained in Table A8 is based on site conditions on the day the inspection was carried out (26 February 2014, 16:15) which may change over time. Hence the information in Table A8 should be used as a guide only.

Figure A8: Sample location LWQ-8 (yellow arrow = suggested sampling point)

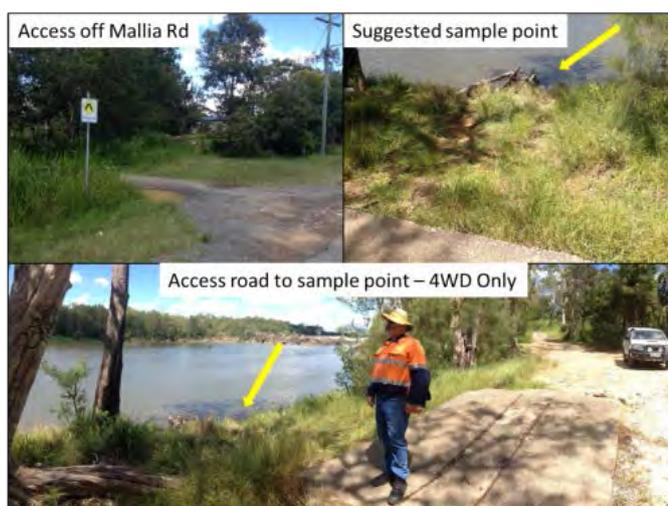
Safety and access considerations for LWQ-9 are summarised in Table A9 below. It should be noted that the information contained in Table A9 is based on site conditions on the day the inspection was carried out (26 February 2014, 16:15) which may change over time. Hence the information in Table A9 should be used as a guide only.

Figure A9: Sample location LWQ-9 (yellow arrow = suggested sampling point)

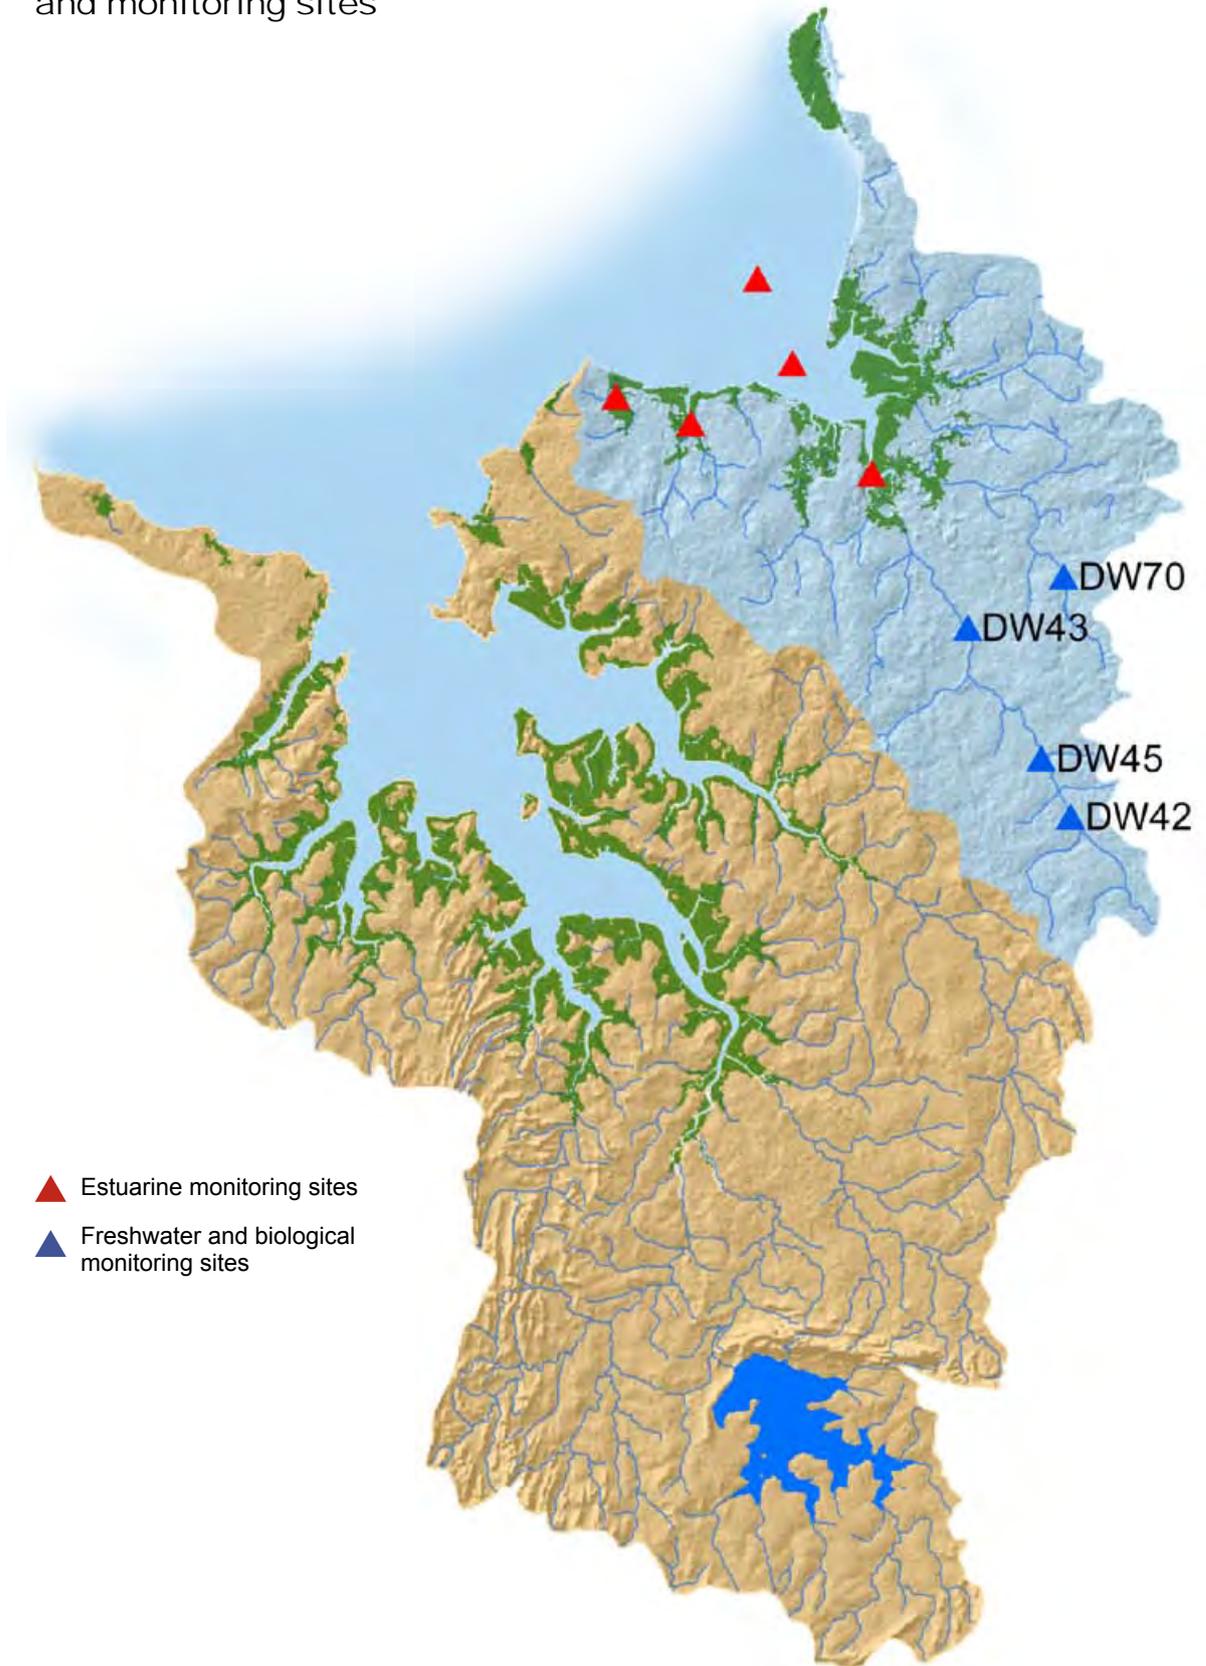
Shoal Bay and Buffalo Creek catchment showing rivers and monitoring sites

- ▲ Estuarine monitoring sites
- ▲ Freshwater and biological monitoring sites

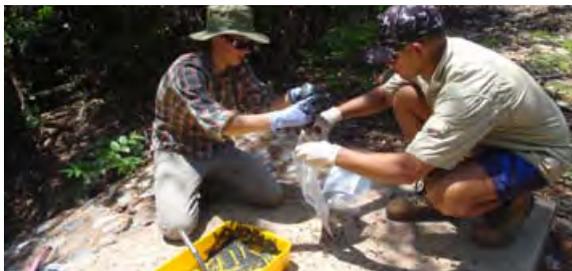
Sampling sediment for assessing pollutant content near the Leanyer-Sanderson sewage treatment plant outfall.

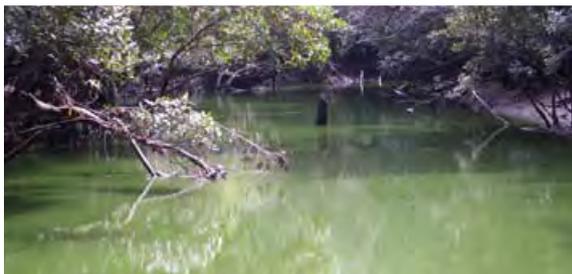
Buffalo Creek receives treated wastewater discharge from the Leanyer-Sanderson sewage treatment plant. Water quality is poor.

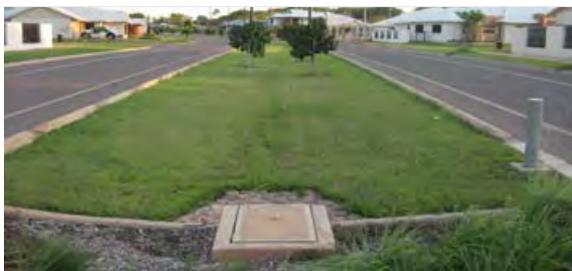
A grass swale (a water sensitive urban design feature), located in the centre of the road, is treating road runoff at Lyons residential development in Darwin before it discharges to Darwin Harbour. Photo: Equatica

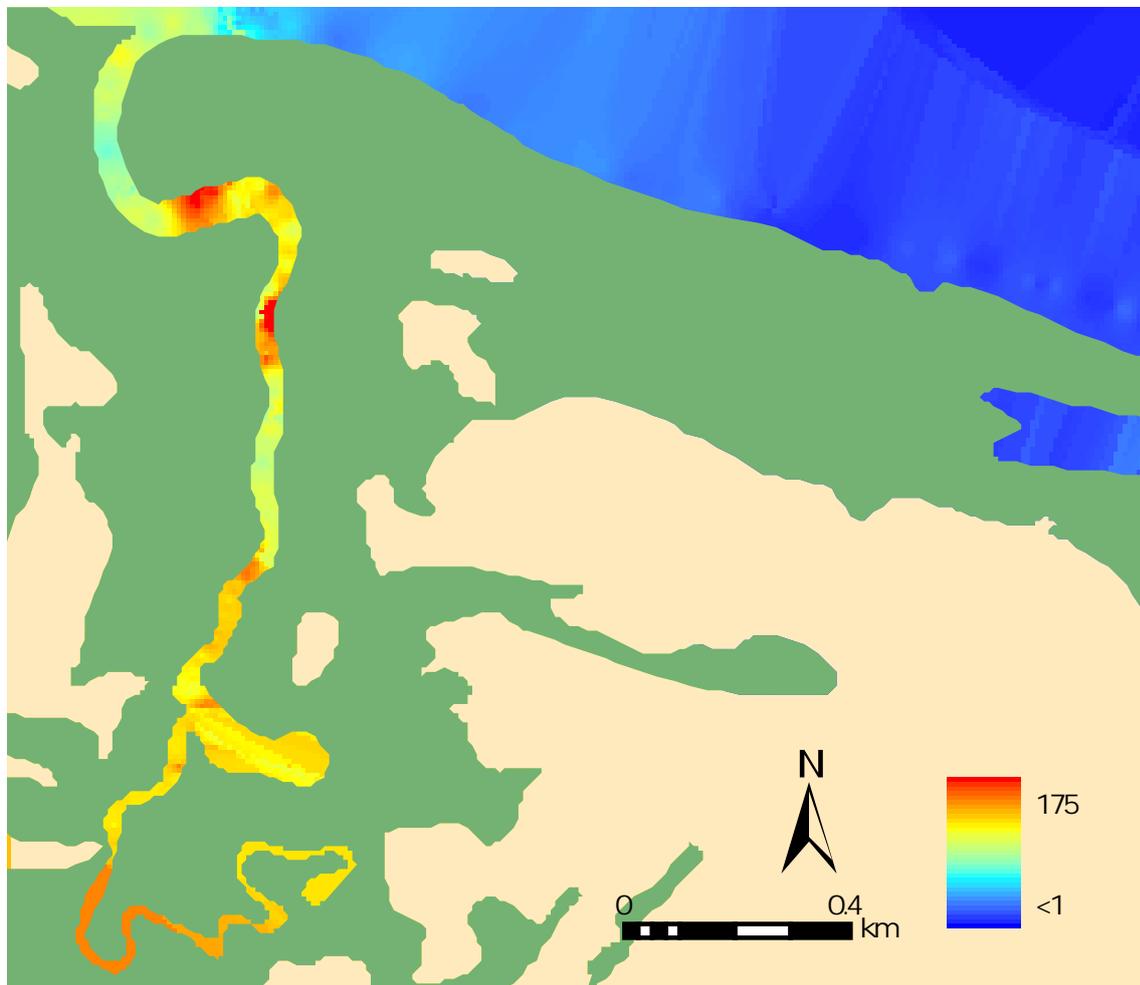
In March 2010, chlorophyll *a* values were high ( $>80 \mu\text{g/L}$ ) in the upper navigable part of the estuary. Greater chlorophyll *a* values ( $100\text{--}170 \mu\text{g/L}$ ) were observed in parts of the mid estuary. Chlorophyll *a* values were approximately  $60\text{--}75 \mu\text{g/L}$  near the boat ramp in the lower estuary, and  $<1 \mu\text{g/L}$  in Shoal Bay. The Darwin Harbour water quality objective for chlorophyll *a* is  $<4 \mu\text{g/L}$  for upper estuaries. These results show water quality in many parts of the estuary is in very poor condition.

Distribution of chlorophyll *a* ( $\mu\text{g/L}$ ) in Buffalo Creek in March 2010.

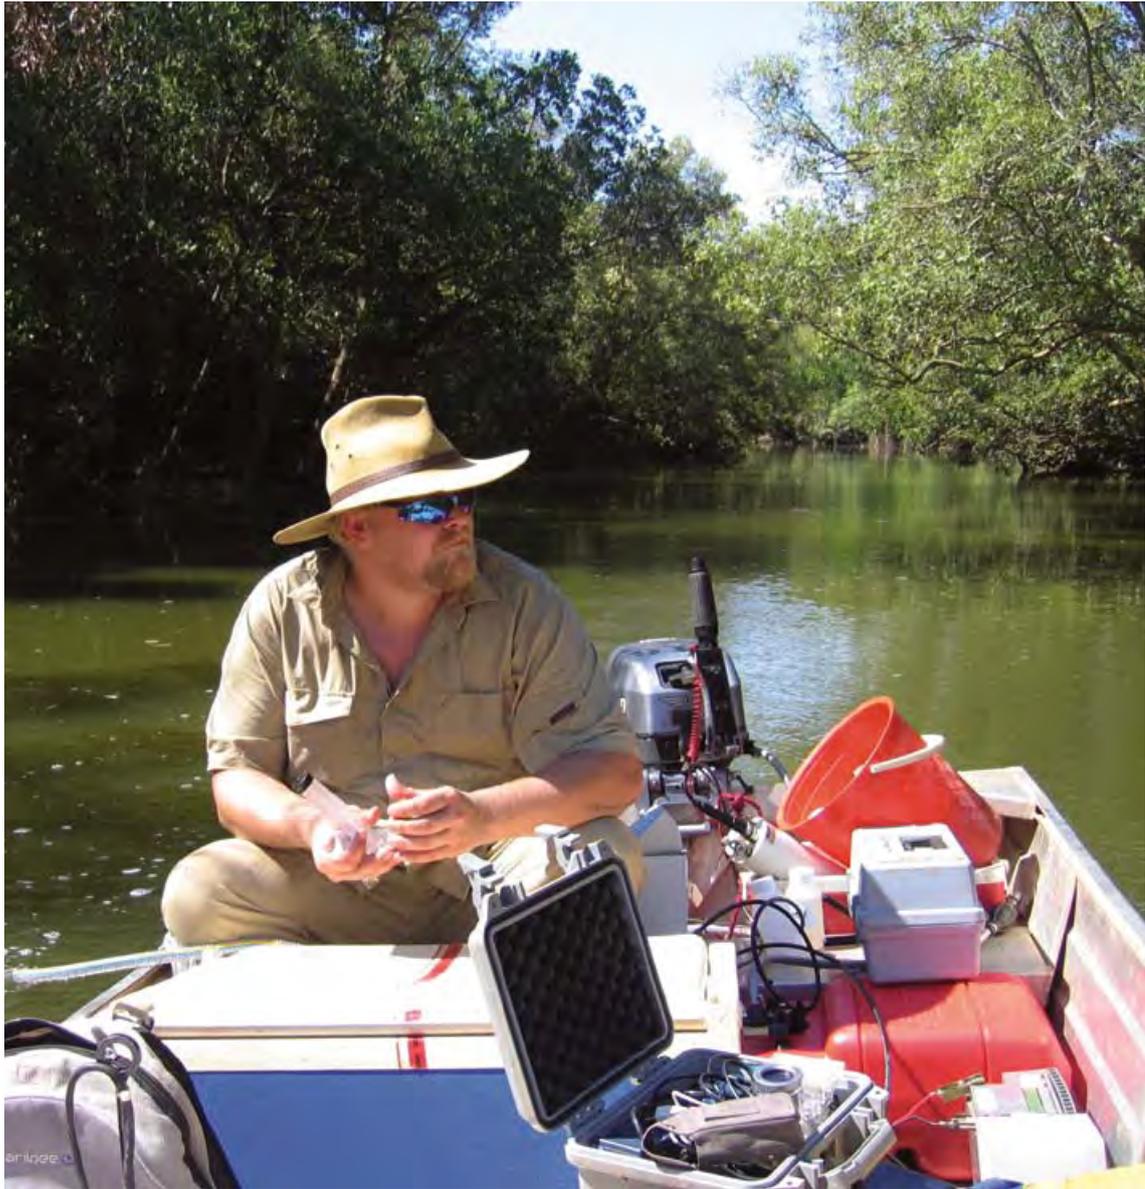
Water quality sampling in Buffalo Creek. Buffalo Creek receives treated wastewater discharge from the Leanyer-Sanderson sewage treatment plant. Water quality is poor, with very high chlorophyll levels – hence the noticeable green colour of the water during this sampling. Photo: Julia Fortune

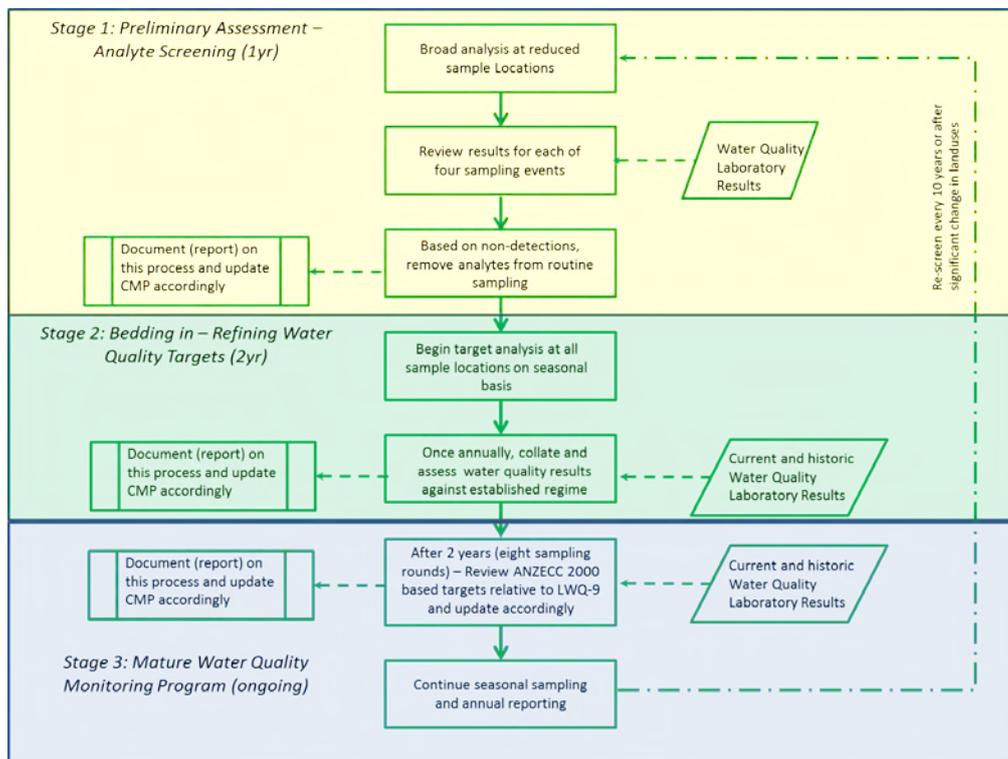
**Figure 1:** Flow diagram for the role out of the Lagoons Water Quality Monitoring Plan (cost estimate applies to Stage 1: *Preliminary Assessment – Analyte Screen* only)

The following cost estimate is for the role out of Stage 1 of the Lagoons Water Quality Monitoring Plan, *Preliminary Assessment – Analyte Screening* as illustrated in Figure 1 (yellow section).
